Manhole Inspection Summary

Manhole # S49M__020MH

Insp Date: **9/3/08 10:44 AM**

Location Address: **2439 boston st**

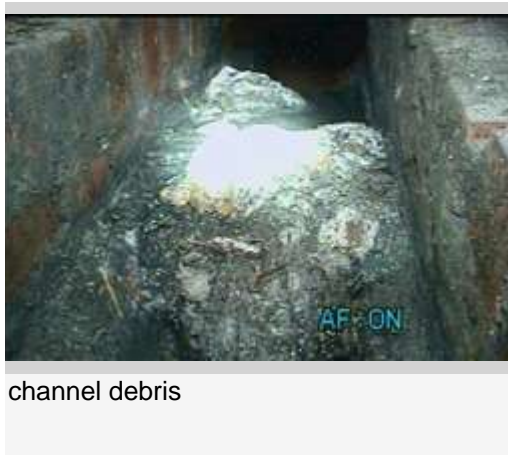
Defect 4

Condition: ☐ Sound ☐ Cracked ☐ Root Intrusion ☐ Deteriorated ☐ Leaks ☒ Debris

channel debris

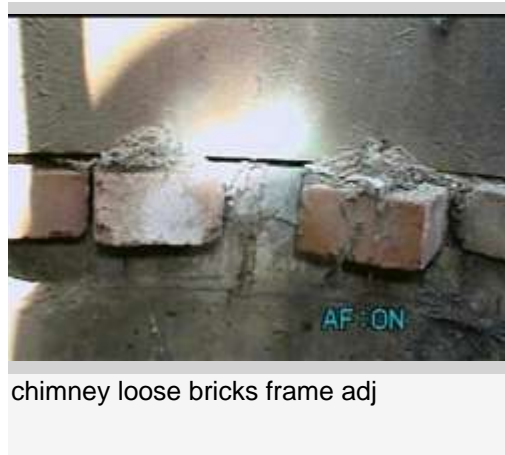
Defect 3

Chimney / Frame Adjustment ☒ Exists Material: **Brick** ☐ Parged Height: **7.5** (in.)

Condition: ☐ Sound ☐ Cracked ☐ Root Intrusion ☒ Loose Brick ☒ Deteriorated

chimney loose bricks frame adj

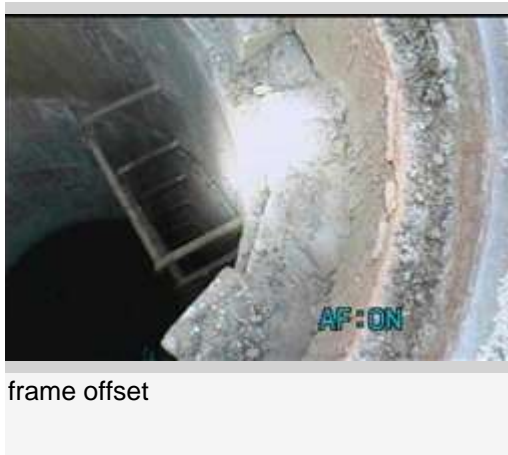
Defect 2

Frame Offset: **3** (in.) Condition: ☒ Sound ☐ Cracked ☐ Leaks

frame offset

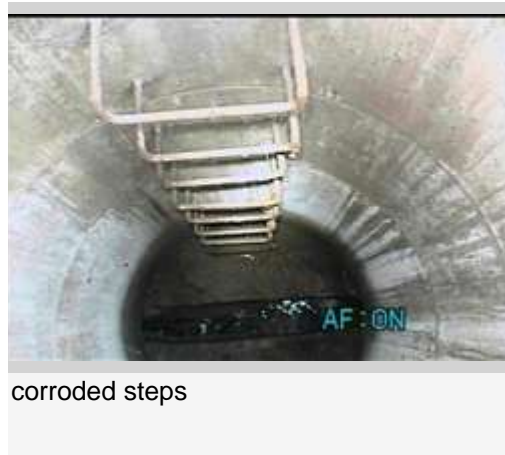
Defect 1

Steps Count: **8** Missing: **0** ☒ Corroded

corroded steps

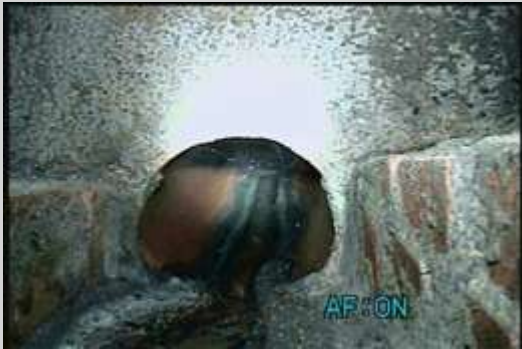
12 O'Clock Outflow

8 in. Circular Gravity Sewer
Pipe Out @ 12 O'Clock

Pipe Material: **Clay** ☐ Pipe Lined

Invert Depth: 11.10 (ft.) Flow Characteristics: **Slow**

Infiltration: **None** Pipe Seal Cond: **Unknown**

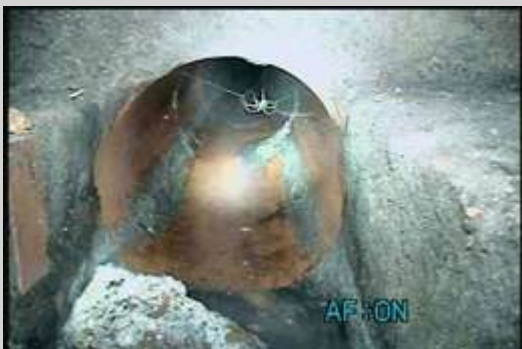
6 O'Clock Inflow

8 in. Circular Gravity Sewer
Pipe In @ 6 O'Clock

Pipe Material: **Clay** ☐ Pipe Lined

Invert Depth: 10.88 (ft.) Flow Characteristics: **Slow**

Infiltration: **None** Pipe Seal Cond: **Unknown**
